Technical Report

Cyclic Load Testing of Unreinforced Masonry Walls

Daniel P. Abrams and Nirav Shah

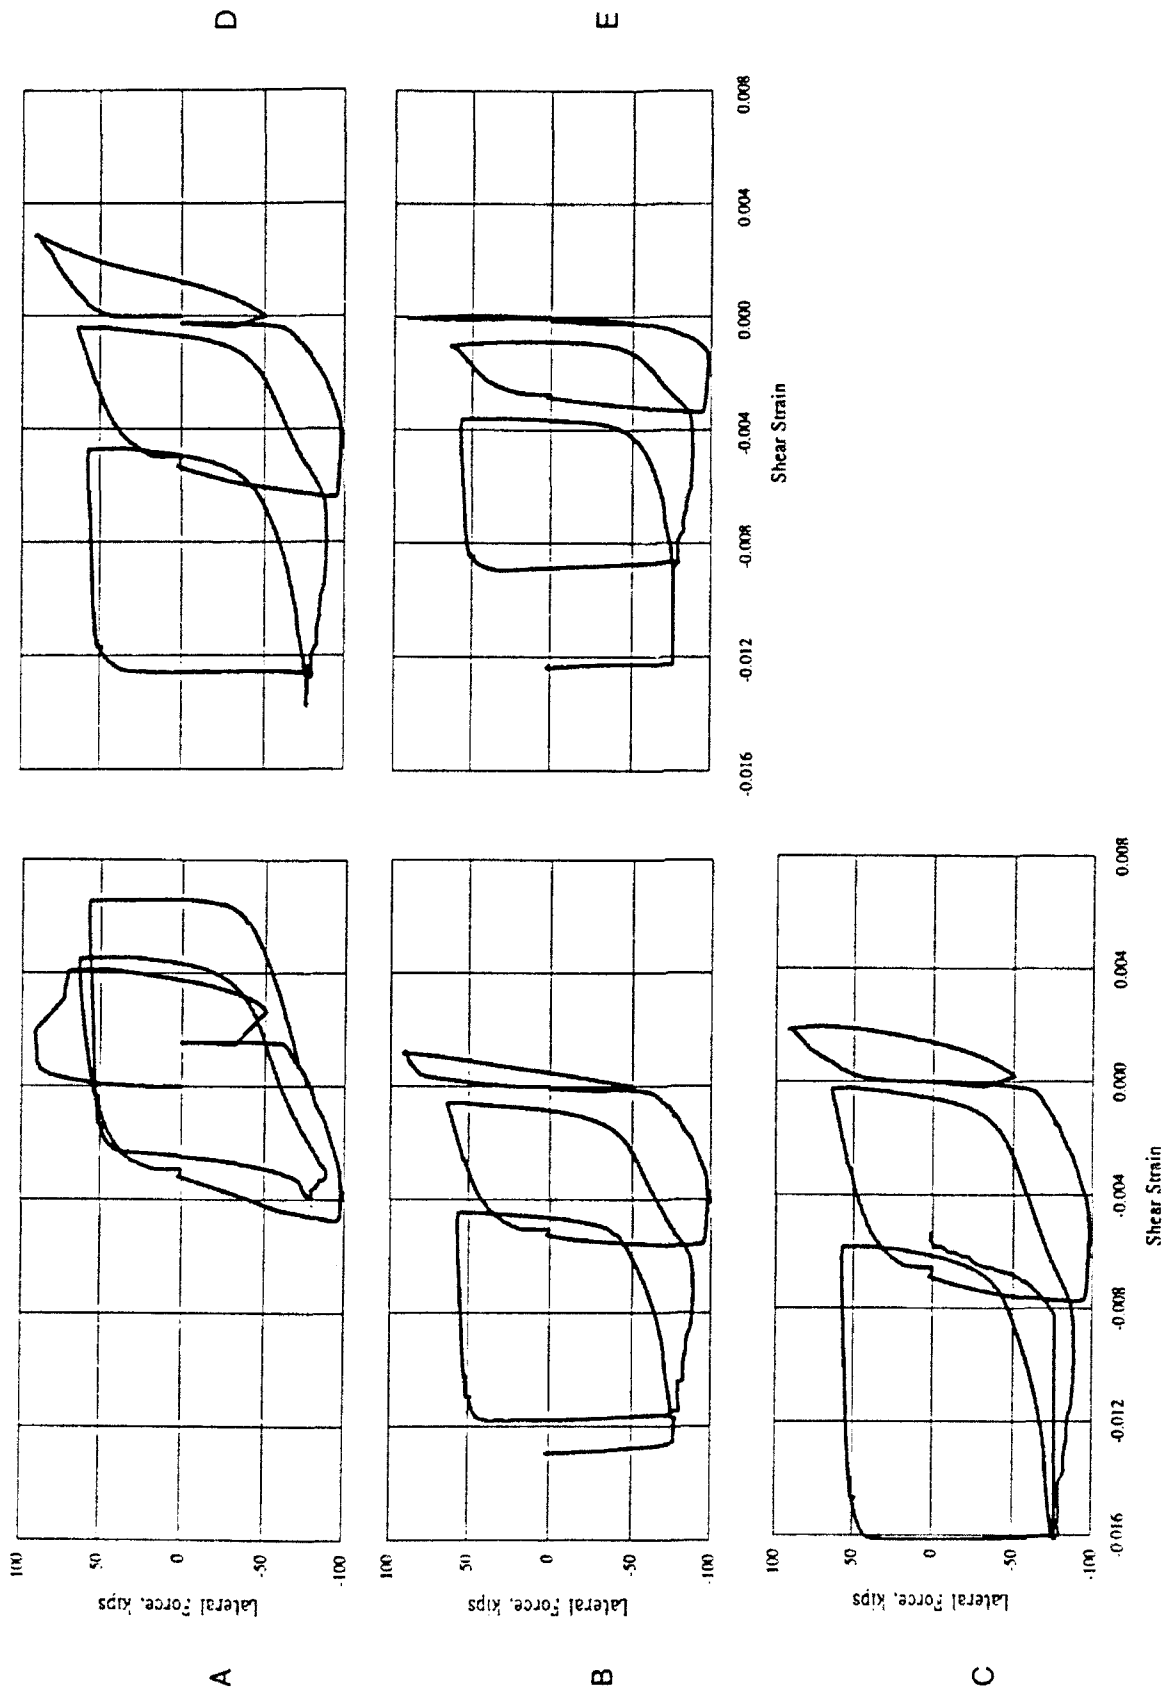
Fig. A.2 Measured Relations between Lateral Force and Shear Strain: Specimen W1

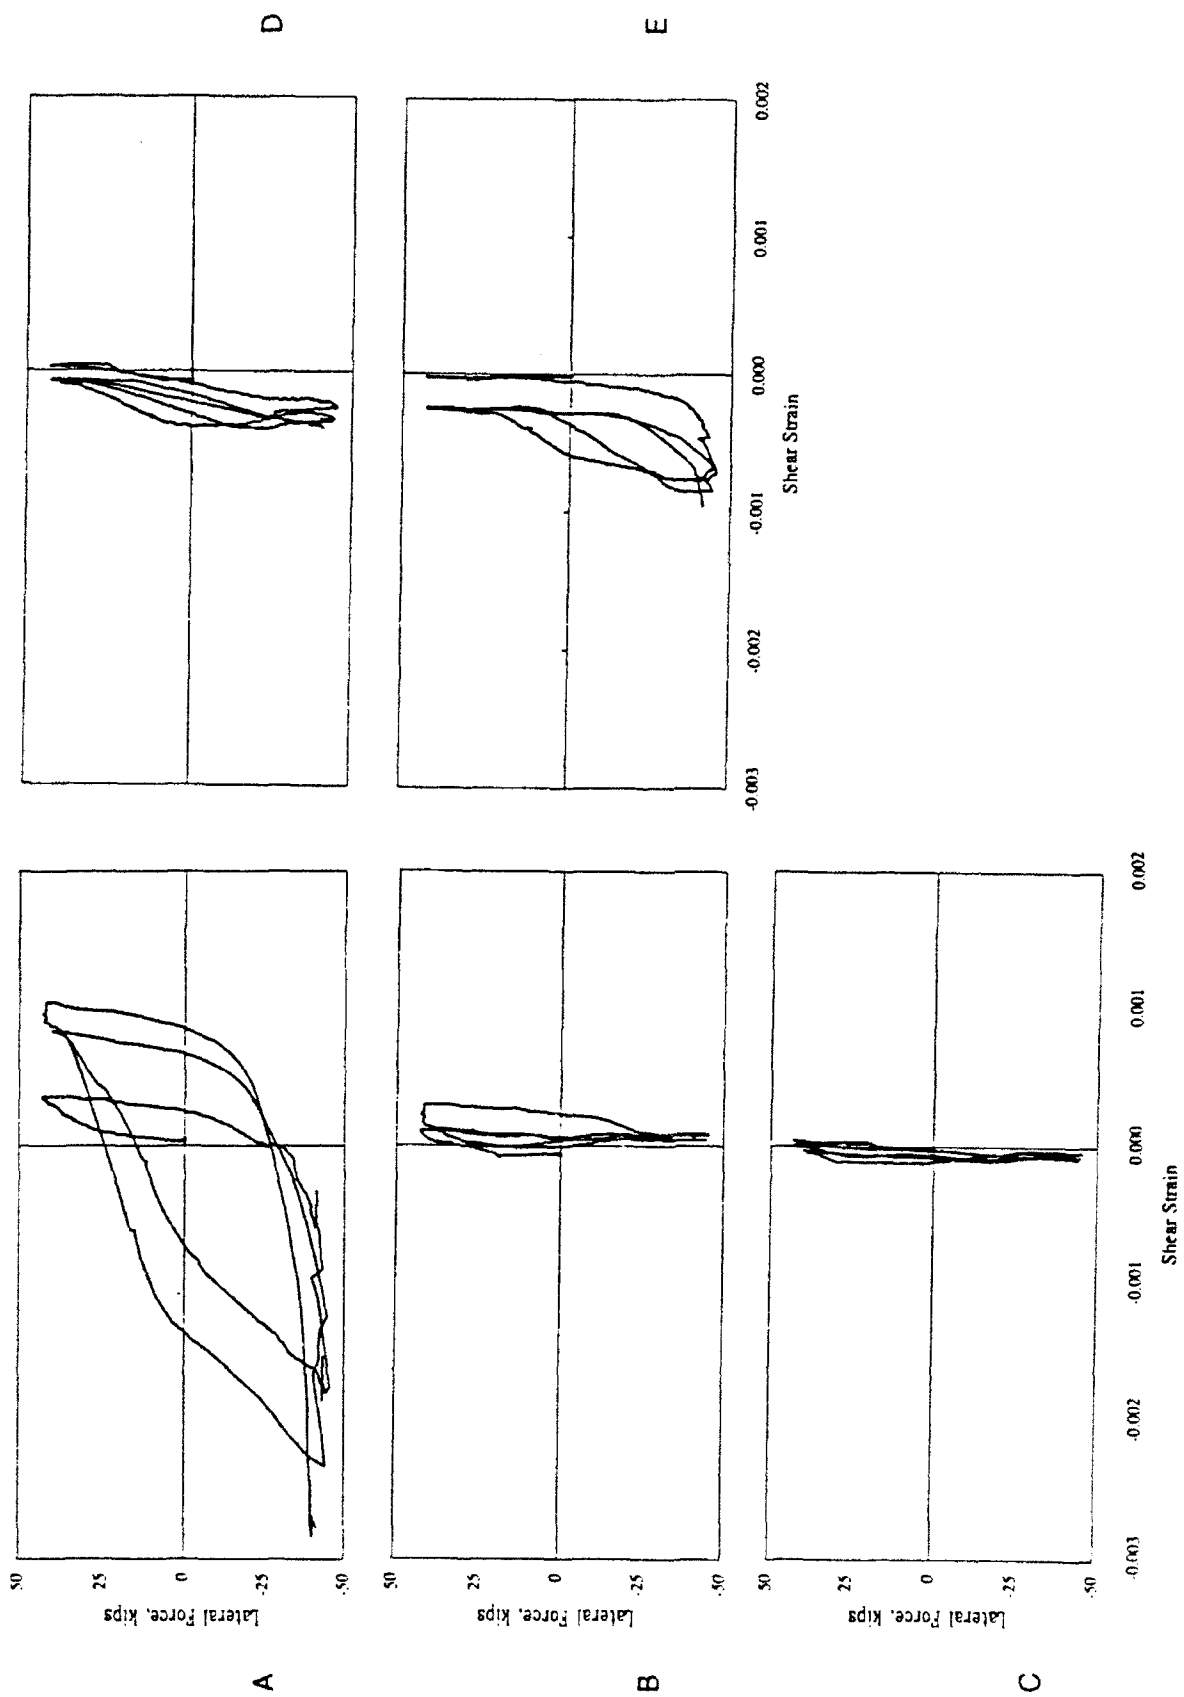
The excessive values of shear strain for Wall 2 at point A is because a crack passed through the gage length.

Fig. A3 Measured Relations between Lateral Force and Shear Strain: Specimen W2

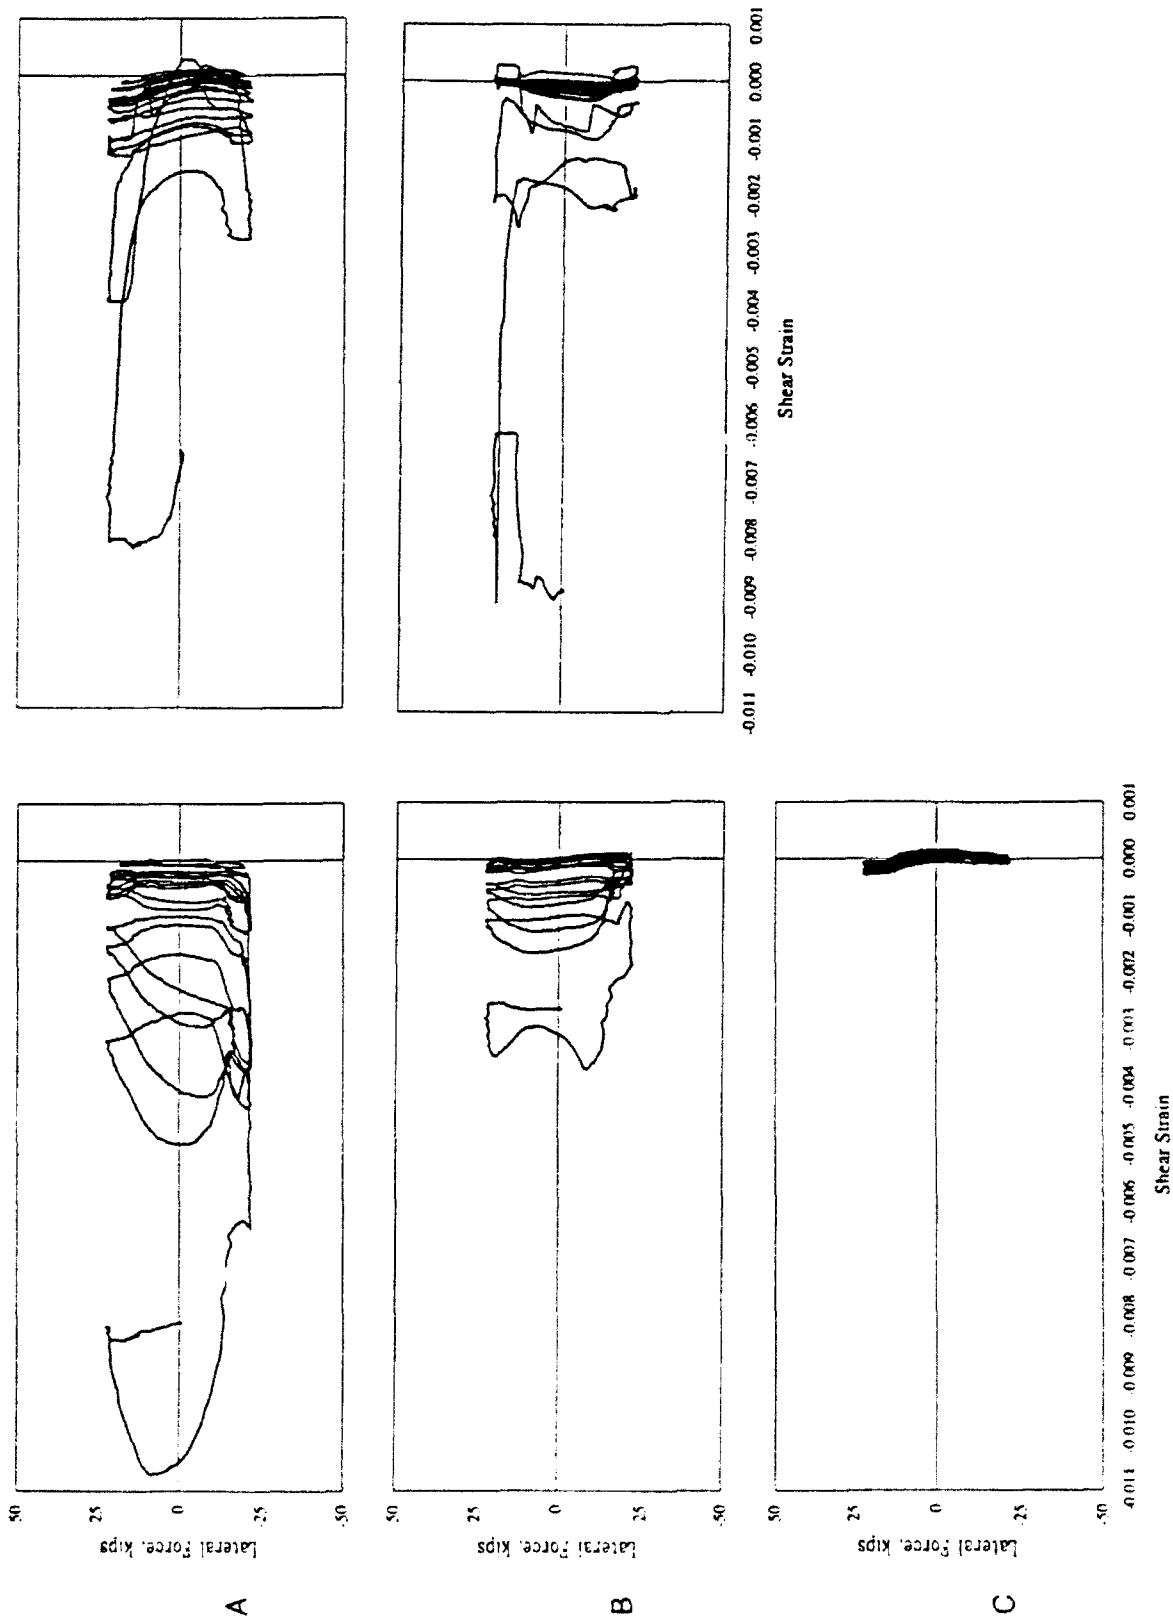
Fig. A.4 Measured Relations between Lateral Force and Shear Strain: Specimen W3

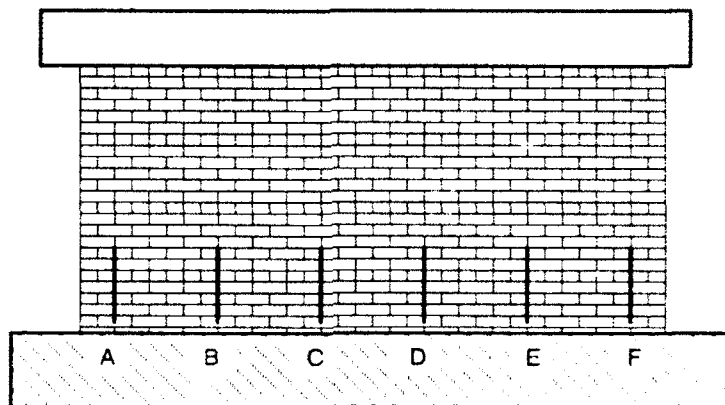
As noted in Chapters 2 and 4, vertical strain at six points across the bottom of the wall were measured with displacement transducers. The distribution of vertical strains for various force levels is shown in Fig. 4.10. Vertical strains were deduced from the vertical displacement transducers shown in Fig. A.5. These strains represent an average of the normal strains across the gage length. On the following pages of this appendix, the measured relations between lateral force and vertical strain at individual points (A through F) are given as reference material.

Figure A.5 Vertical Strain Measurement Locations

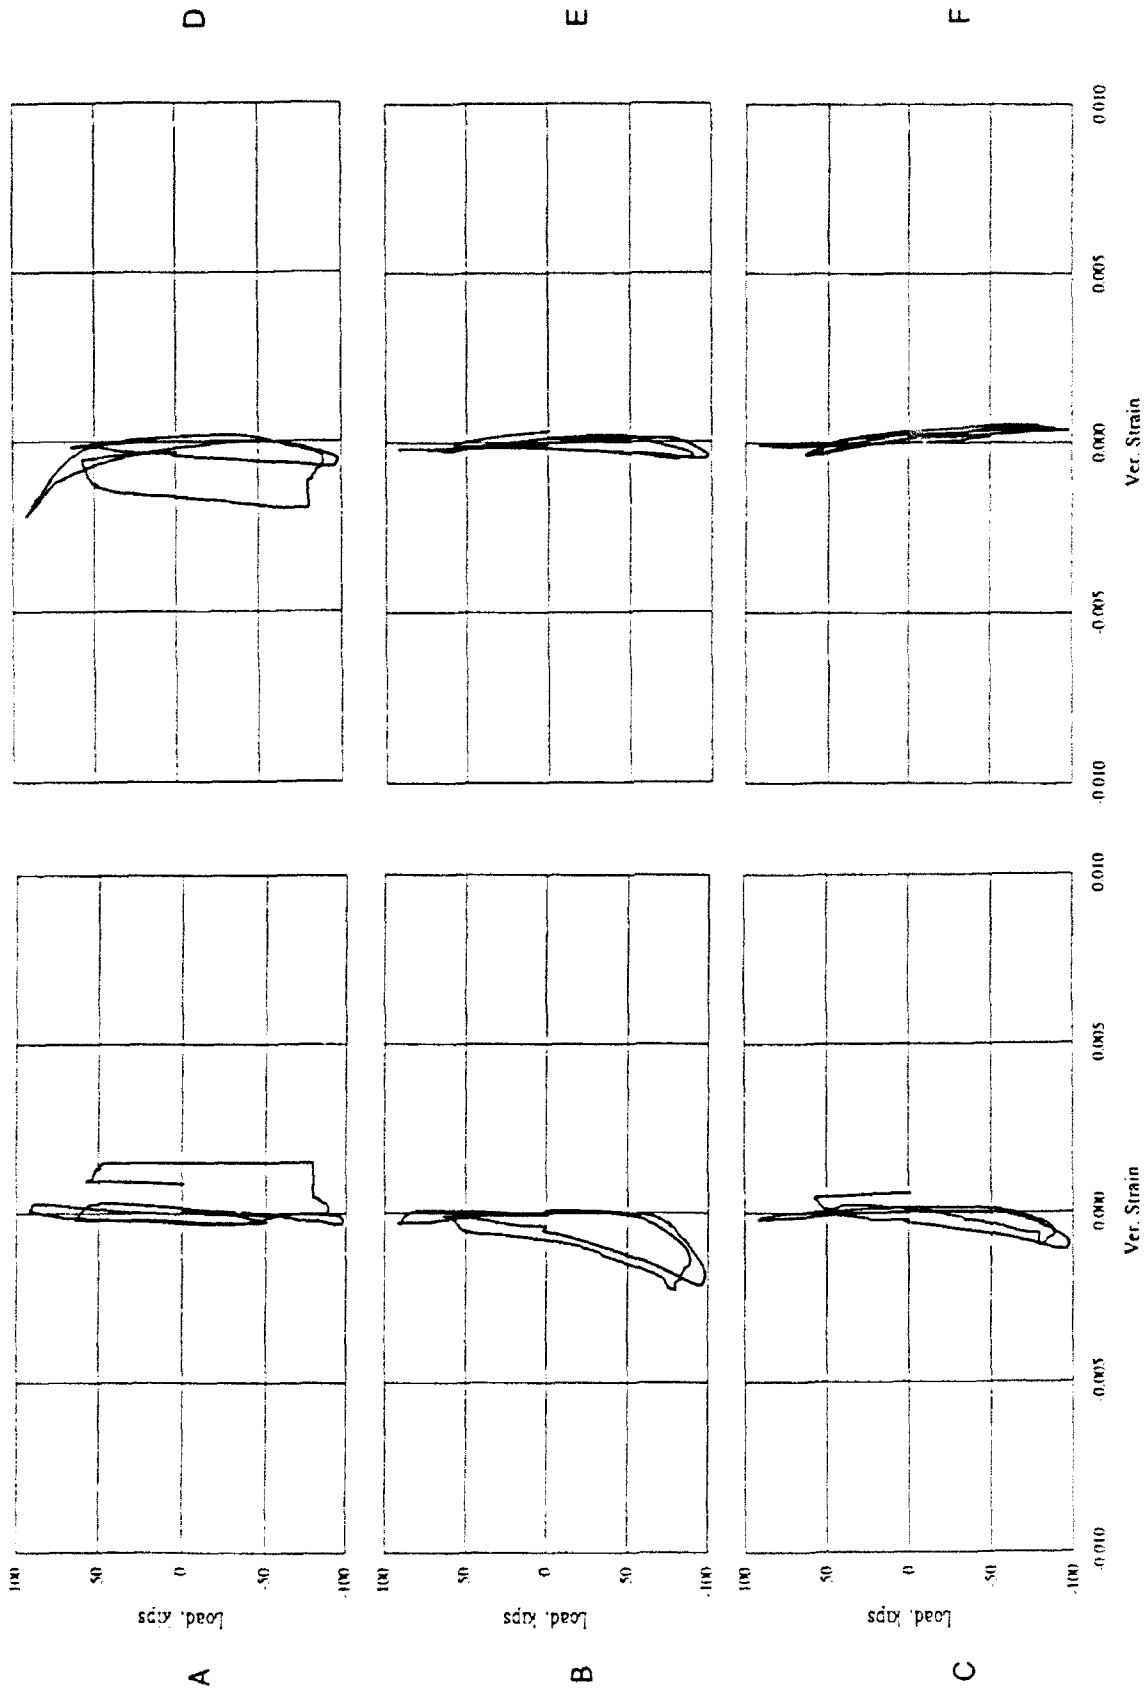
Fig. A.6 Measured Relations between Lateral Force and Vertical Strains: Specimen W1

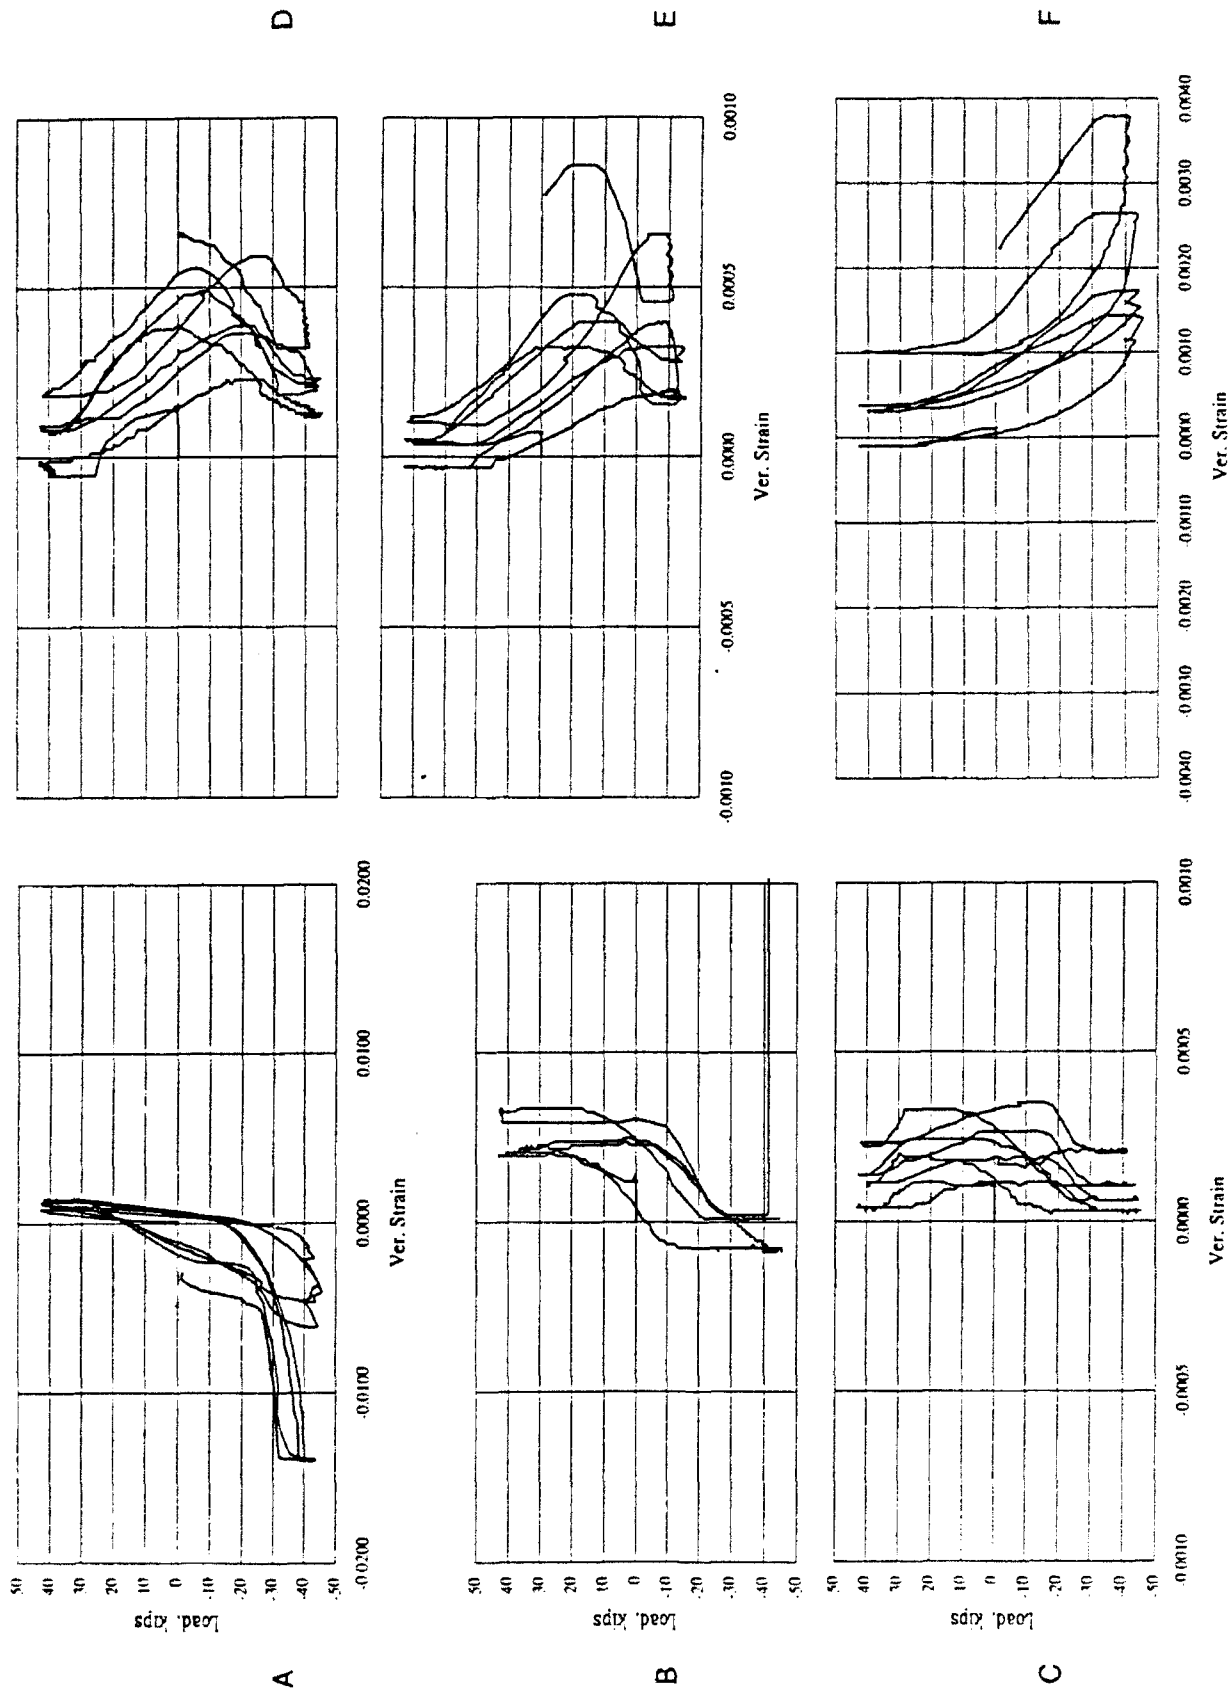
Fig. A.7 Measured Relations between Lateral Force and Vertical Strain: Specimen W2

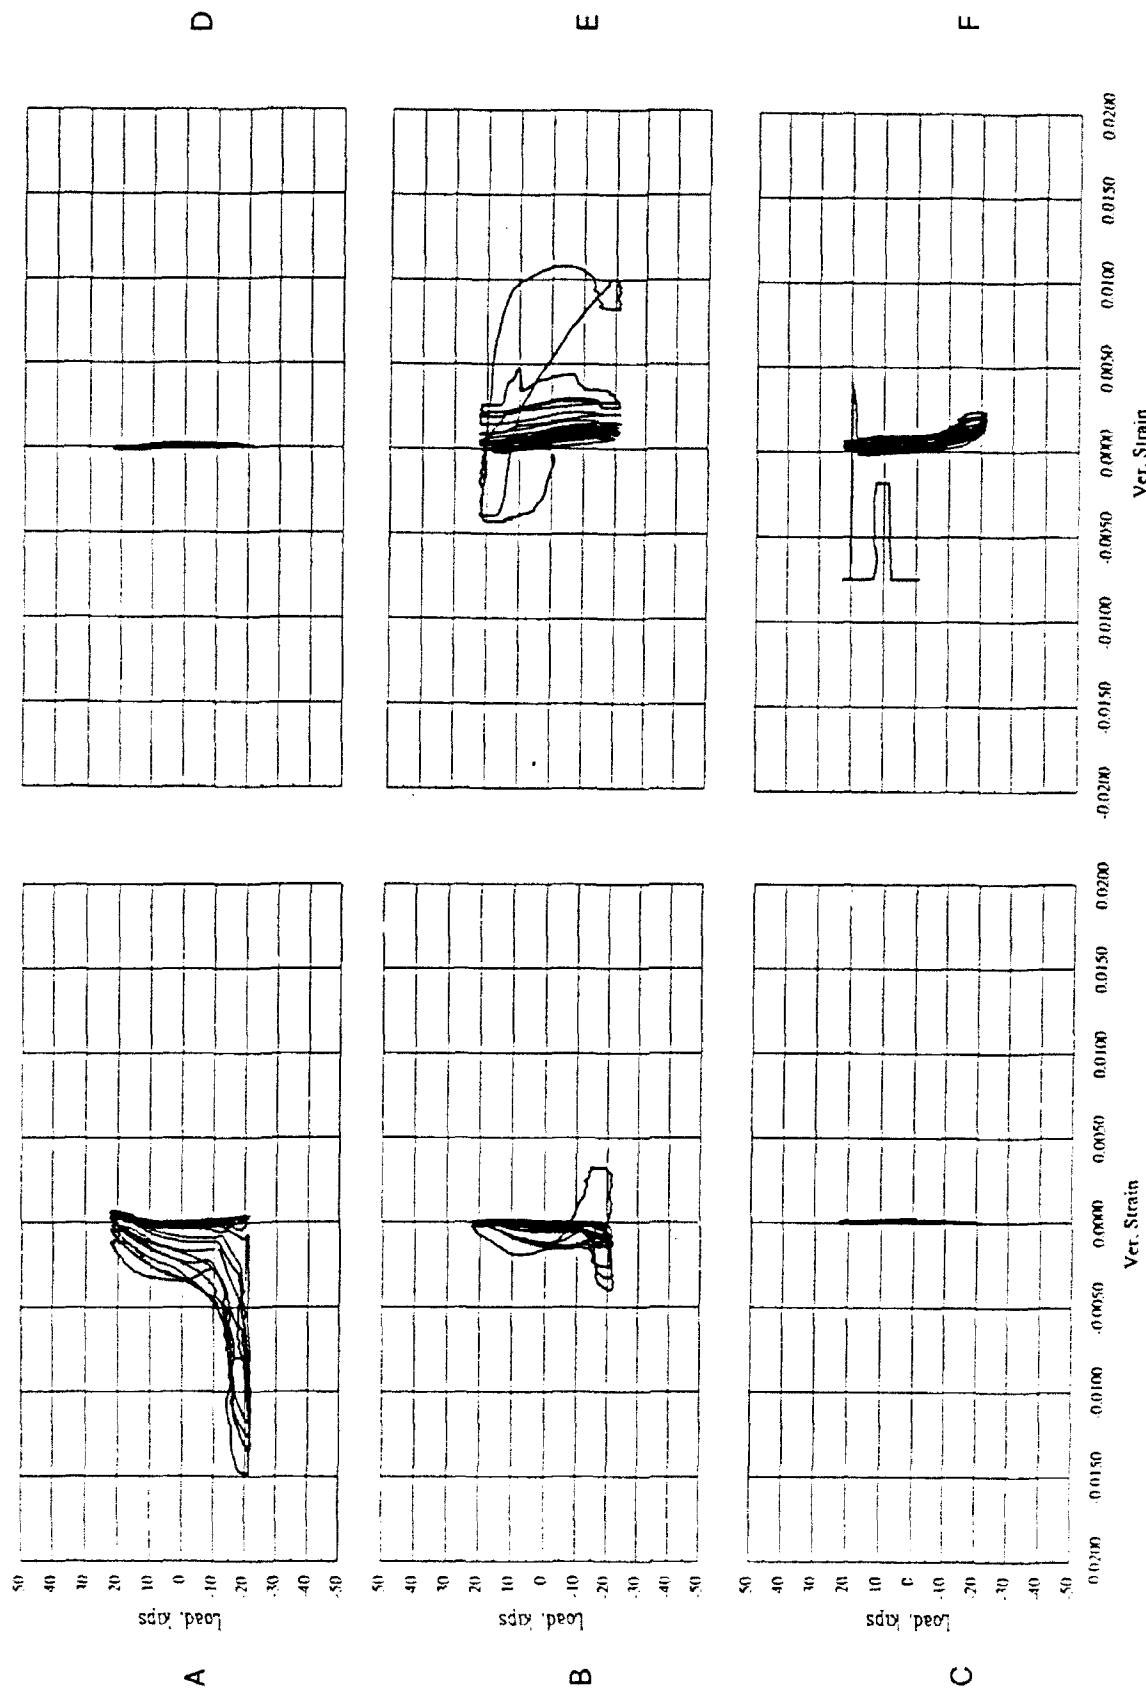
Fig. A.8 Measured Relations between Lateral Force and Vertical Strain: Specimen W3
